Inspection Report

Sample Report #4

Property Address:
601 Bluewater Dr.
Nashville TN 37217

21st Century Home Inspections, LLC

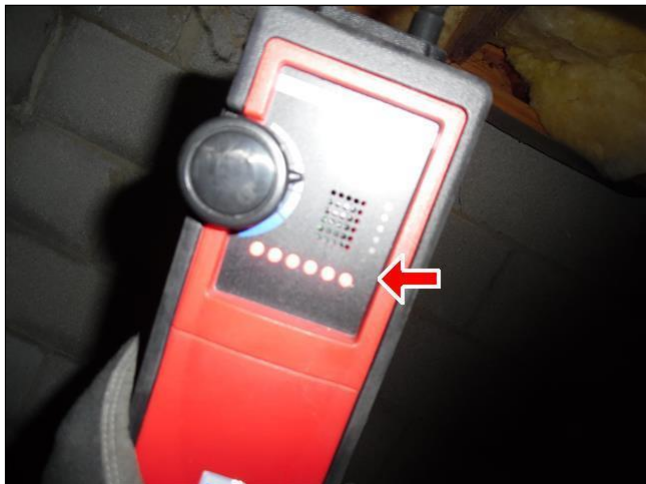
6.2 Item 5(Picture)

(2) Noted this elbow in the black iron gas pipe located in the crawlspace, coming from the gas meter, is leaking gas. This gas pipe feeds the water heater and the gas fireplace and the elbow is located toward the front of the home in the corner. The leak was confirmed by a combustible gas meter. There is enough gas emanating from this leak that you can smell it coming through the crawlspace vent located to the left of the stoop steps. This needs to be repaired immediately by a qualified plumber or gas company technician.

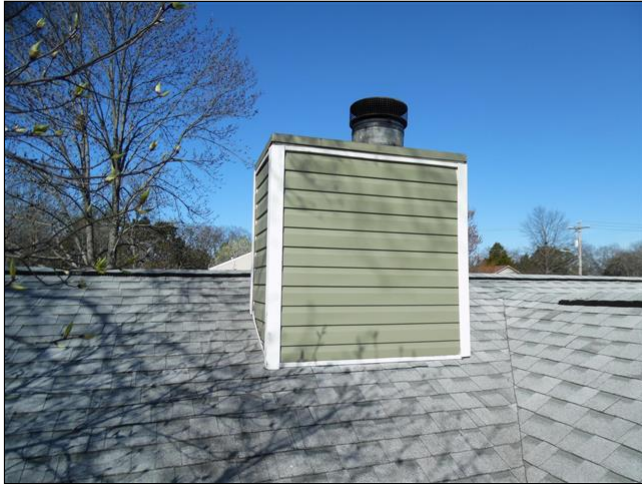
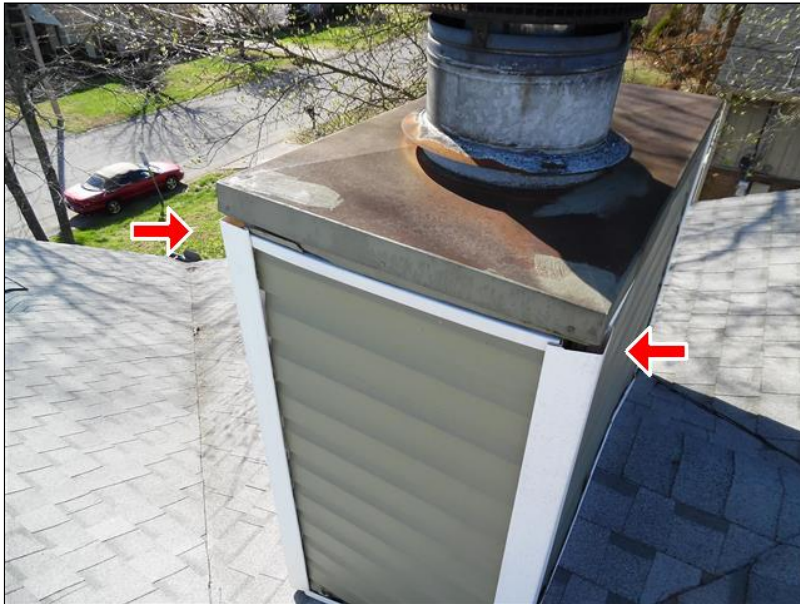
The corner trim on the vinyl sided chimney is not tucked underneath the chimney cap. These open ends will allow water to penetrate and will eventually cause damage to the chimney framing and structure. Minor repair.

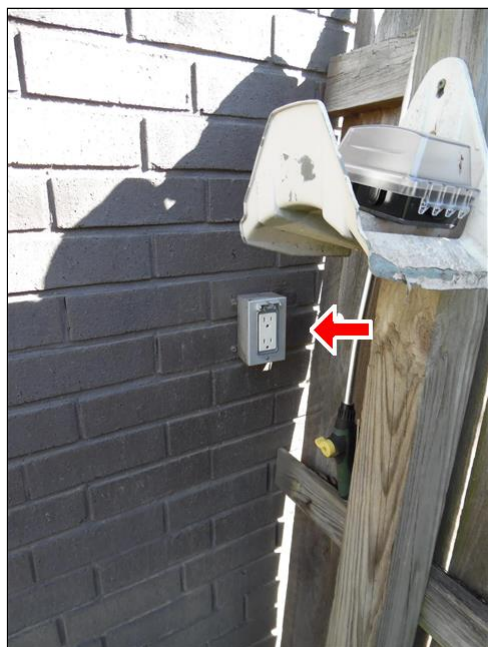
5.3 Item 1(Picture)

This exterior outlet should be covered to prevent water from shorting this circuit out. Minor repair.

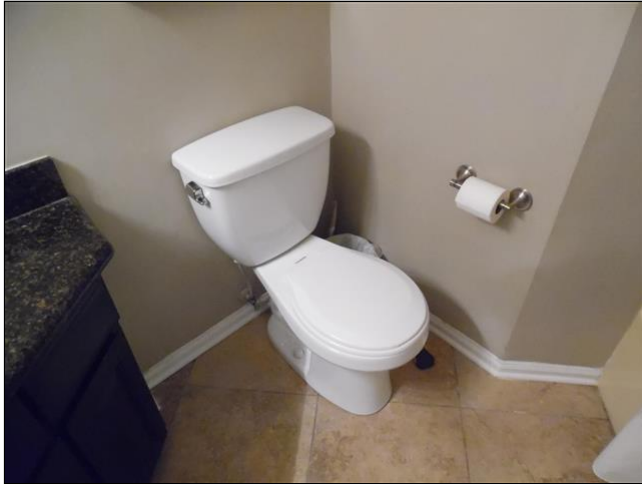
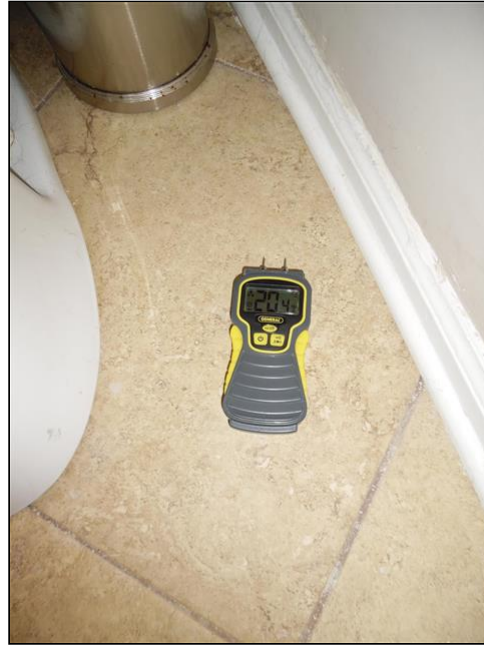
(1) While the toilet is secure to the floor, I did detect moisture with a moisture meter at the base of the toilet at the guest bathroom. This is most likely an indication of a faulty wax seal that needs to be replaced to avoid water damage to the subfloor. This is a minor repair.

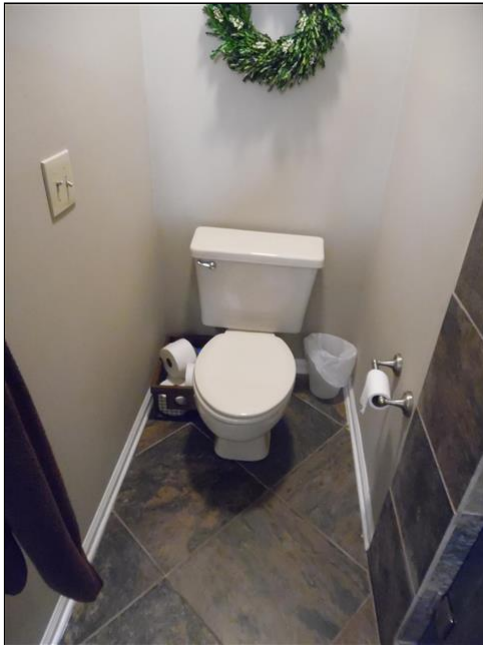
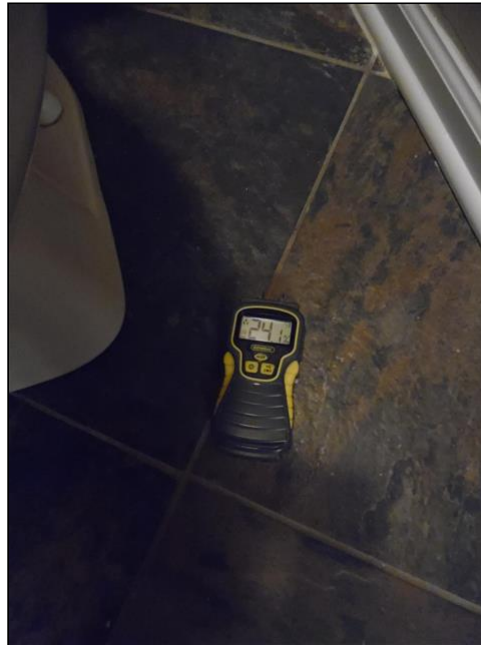
(2) The toilet is loose at floor at the master bathroom and I detected moisture at the base using a moisture meter. Minor repair to replace wax seal and secure toilet to the floor.

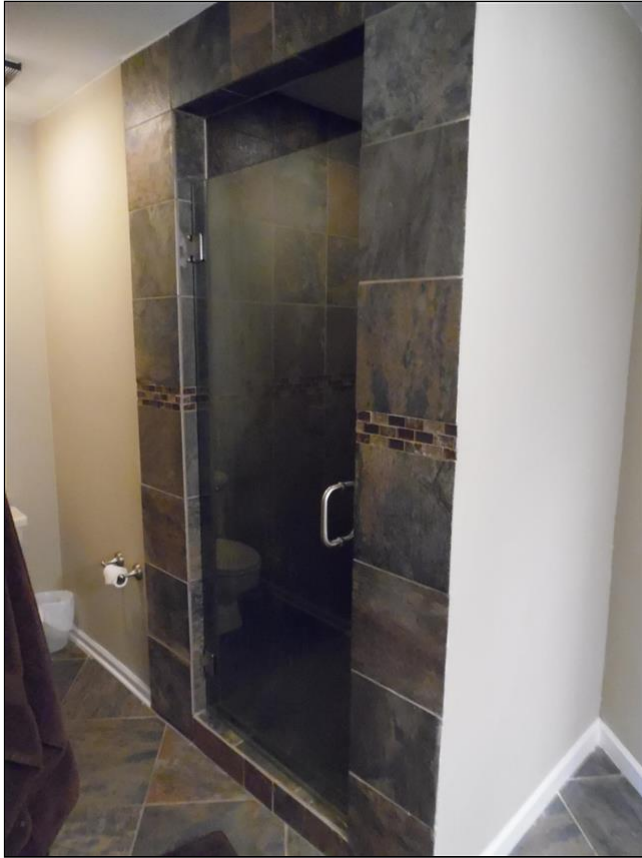
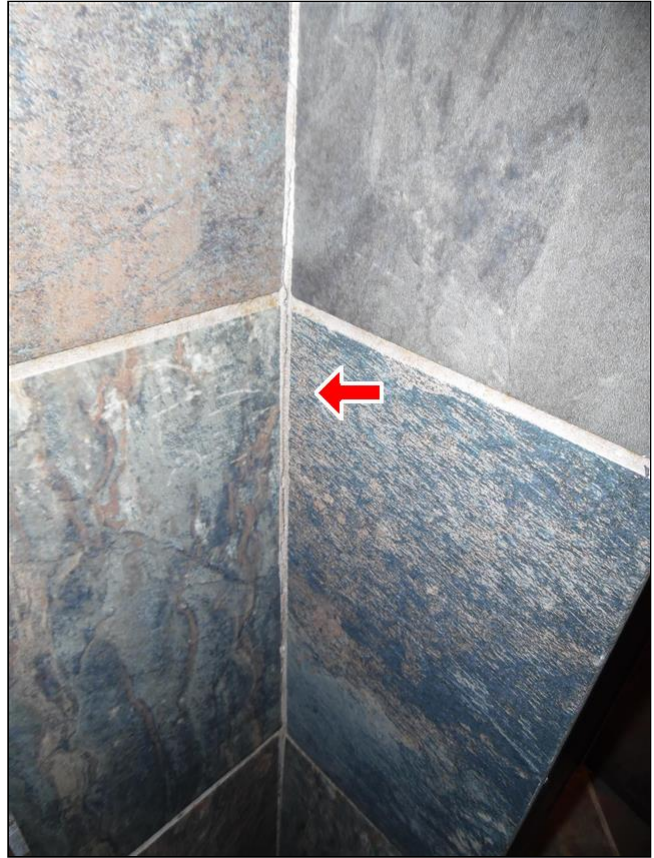
(3) Noted cracked grout inside master shower stall. This is at the inside right corner. While it is a small crack, the grout needs to be repaired to prevent long term water penetration behind the shower surround and subfloor underneath. Minor repair.

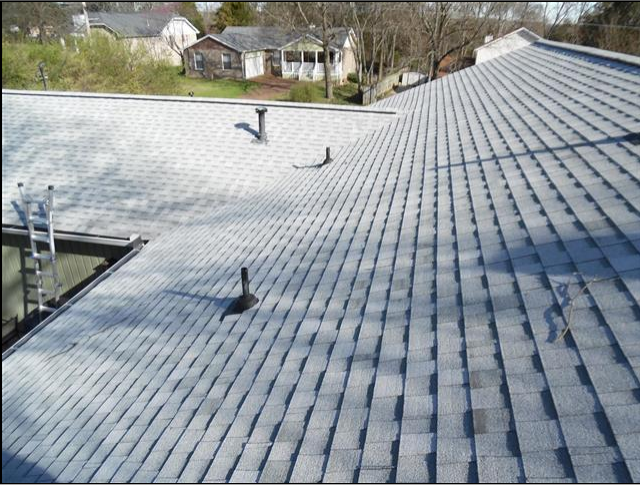
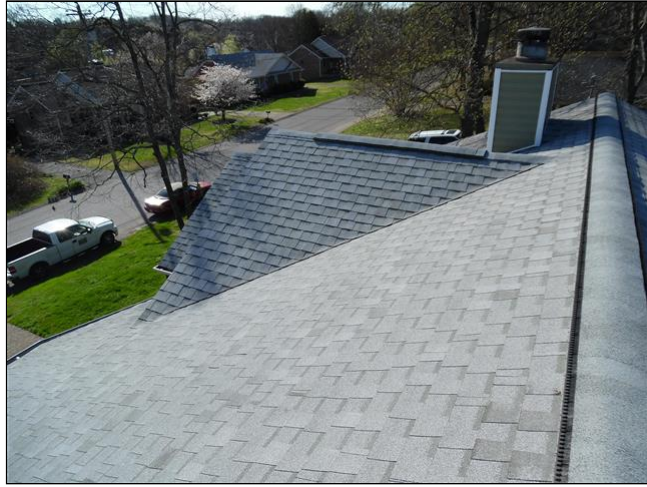
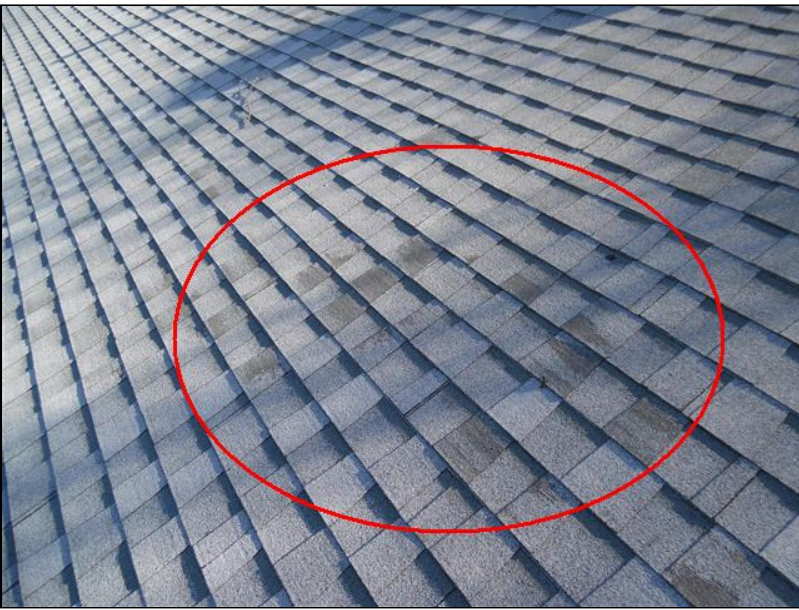
1.0 Roof covering appears to be the original roofing, but has weathered well and is in satisfactory condition. Observed evidence of general degranulation and some areas where the shingles have lost most of the granules. There were no major defects detected at the time of the inspection. Architectural shingles have an estimated useful life expectancy of 15-25 years of normal life and this roofing has provided effective protection for longer than the normal life expectancy. However, I recommend budgeting for replacement <5 years.

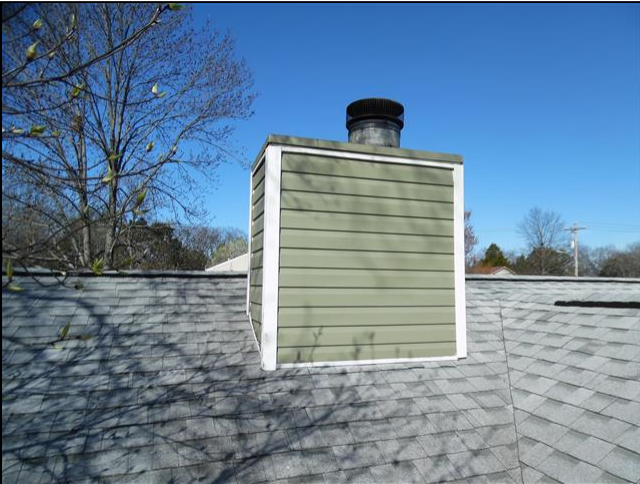
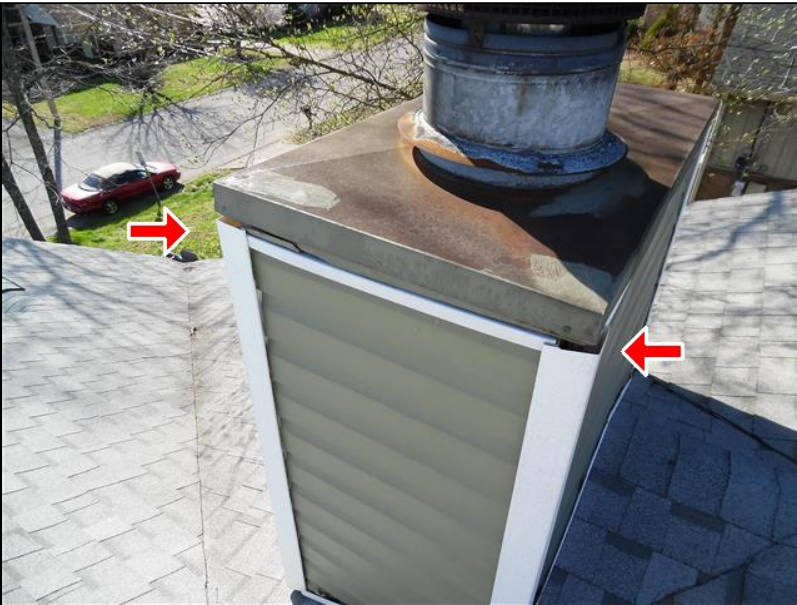
1.2 The corner trim on the vinyl sided chimney is not tucked underneath the chimney cap. These open ends will allow water to penetrate and will eventually cause damage to the chimney framing and structure. Minor repair.

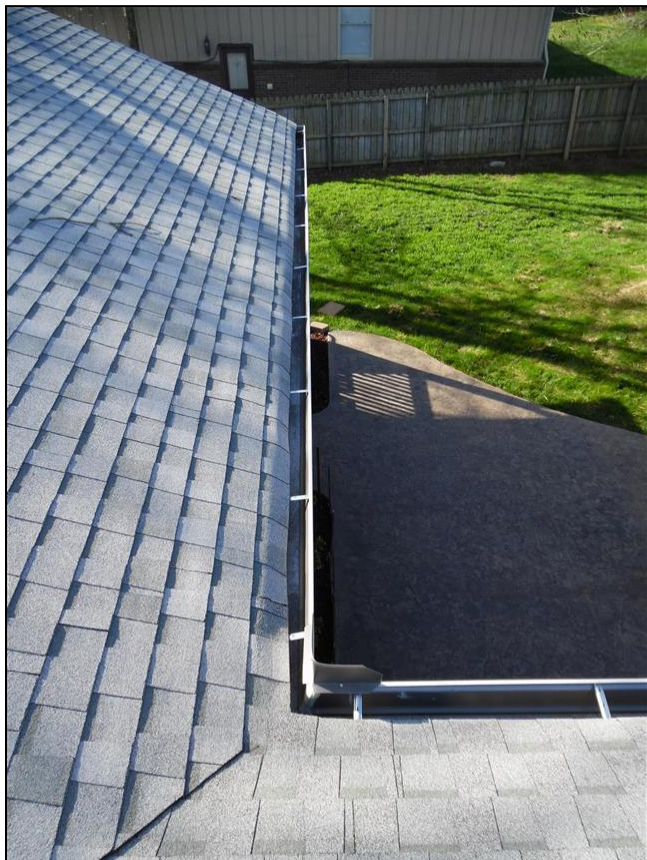
1.3 Item 1(Picture)

1.3 The gutters appear intact, but due to the lack of recent rain, I am unable to determine if gutters leak at seams or spills water.

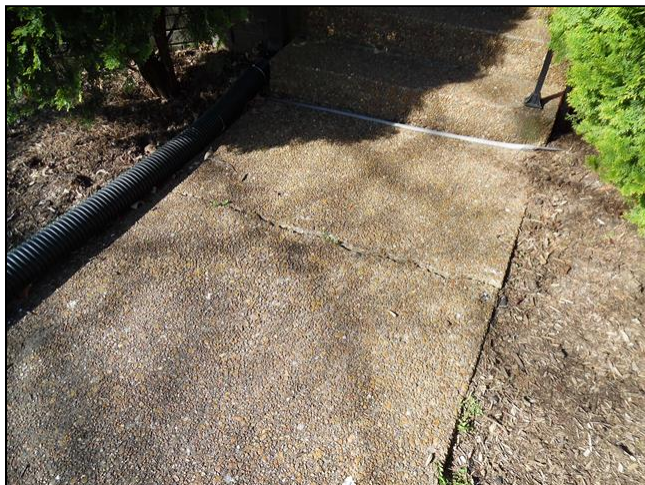
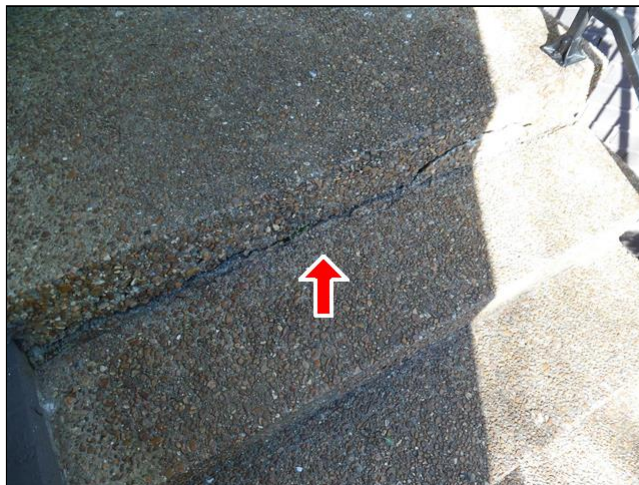
2.3 Noted some normal settlement cracks on the sidewalk and stoop steps. Recommend filling with mortar or cement caulking as needed to prevent further deterioration. Routine maintenance.

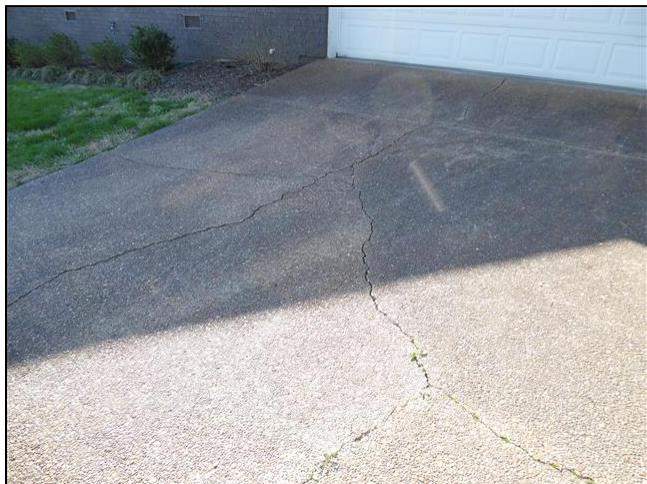
2.4 Item 1(Picture)

2.4 Noted some settlement cracking in the driveway. This is normal for the age of the home. Recommend applying appropriate cement caulking for aggregate drives to fill the cracks to prevent further deterioration. Monitor.

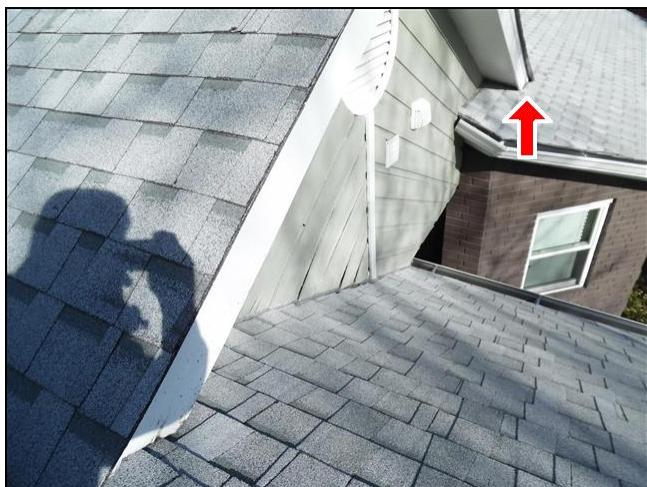
2.5 Item 1(Picture)

2.5 (1) Noted this small area of the rake board trim at the front of the home that had some wood deterioration at the interface between the trim and the roofing. Minor repair.

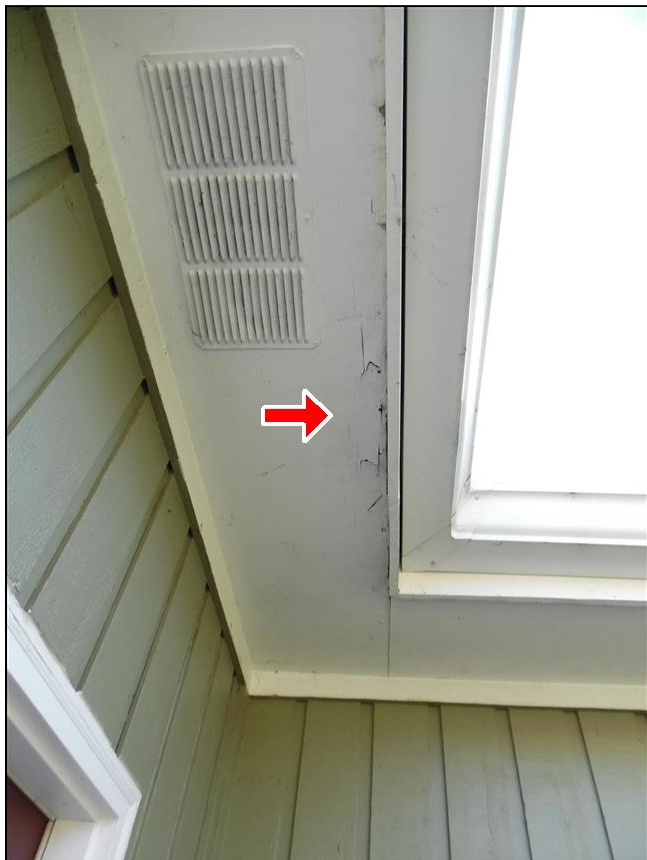
2.5 Item 3(Picture)

2.5 (2) This area of the soffit to the left of the rear exterior sliding glass door should be scraped and repainted to keep water from penetrating further. Minor routine maintenance.

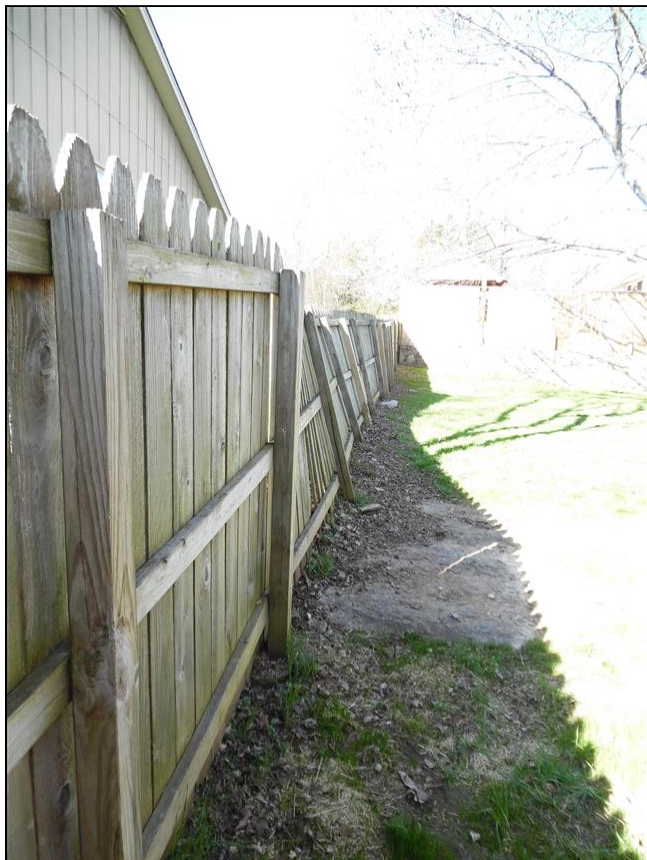
2.6 Item 1(Picture)

2.6 While the wooden fence is standing and serving it's function, one side of the fencing is leaning severely and needs to be repaired. This does not affect the permanent structure of the home and is for informational purposes only.

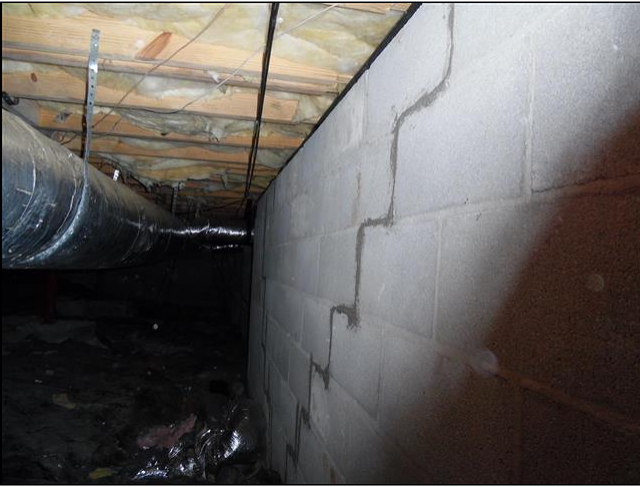
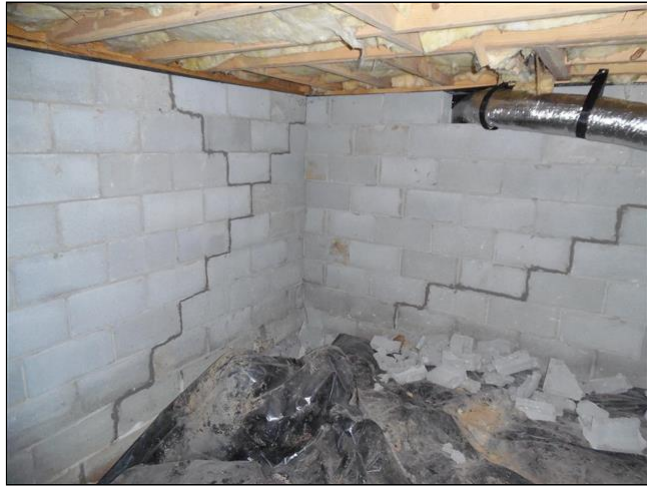
3.0 Noted the presence of repaired stair-step crack(s) in the foundation wall at the front of home. The previous repair made to the wall appears adequate at the time of the inspection. I am unable to determine if the repairs were made to an active or inactive crack. It is recommend that you monitor periodically and address as needed.

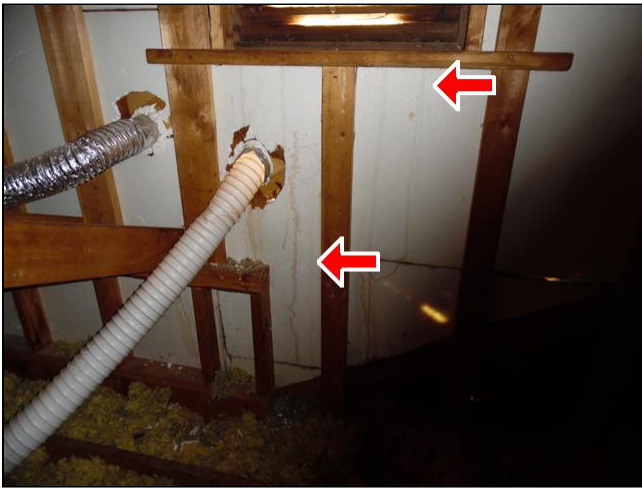
3.1 Item 4(Picture)

3.1 (2) I did note signs of water stains below this gable vent in the front of the home. It was dry at the time of the inspection and appears to be rain water that's blown from the vent. I'm unable to determine the frequency or extent of the leaking or if this is an active area. Monitor and address as needed.

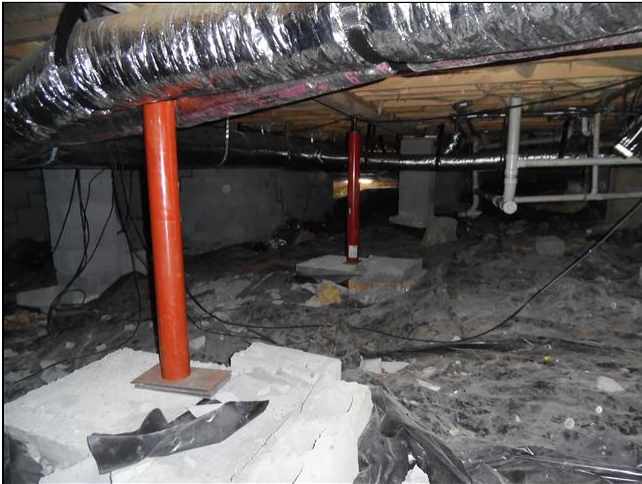
3.3 Item 1(Picture)

3.3 Because of the prior repairs to the floor structure, this home employs a combination of masonry block (original construction), screw jacks and wooden columns.

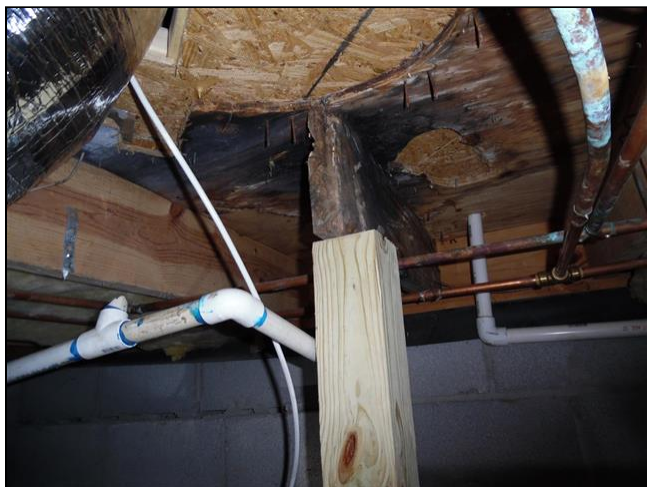
3.4 Item 1(Picture)

3.4 Noted prior repairs made to this area of the floor structure. It appears to have addressed prior water damage to the floor system. This floor joist should have been replaced, rather than cut. The current repairs have removed the deteriorated section of the joist, then added wooden columns on either side of the cut. This is not a proper repair. While I detected no indications of settling inside the home at the time of the inspection, I'm unable to determine if this repair will allow structural problems to this area of the floor in the future.

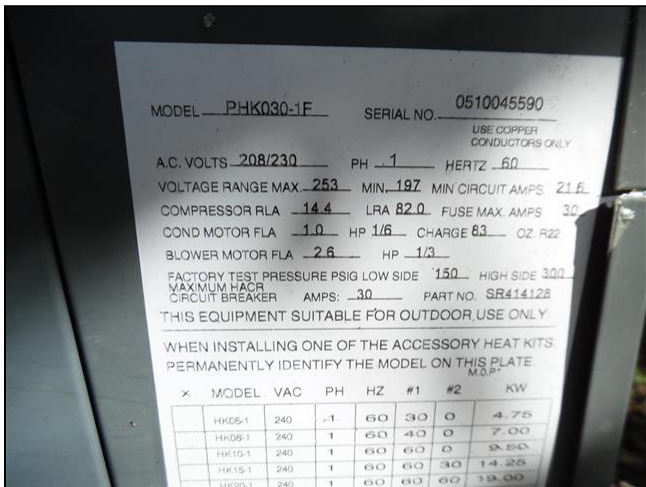
4.11 Item 1(Picture)

4.11 Manufacturers label for the HVAC system shows manufactured Oct/2005. Typical life expectancy for heating/cooling systems range 15-25 years or more if well maintained or in a low use condition. I estimate this heating/cooling system has 10-15 years of useful life left.

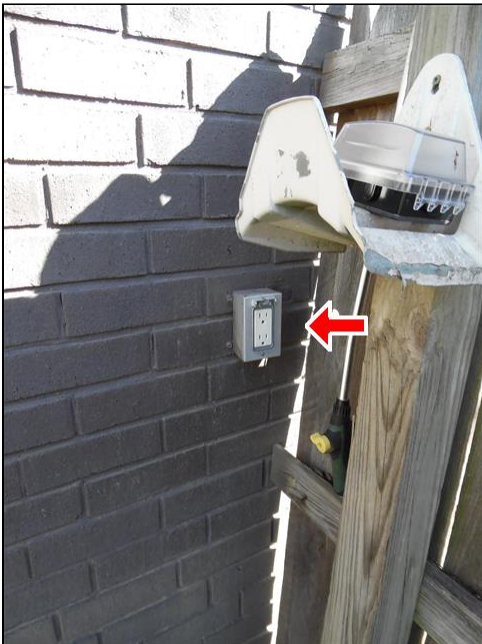
5.3 Item 1(Picture)

5.3 This exterior outlet should be covered to prevent water from shorting this circuit out. Minor repair.

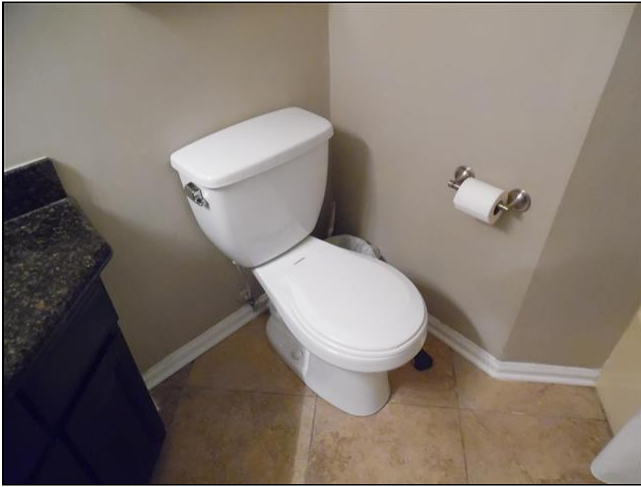
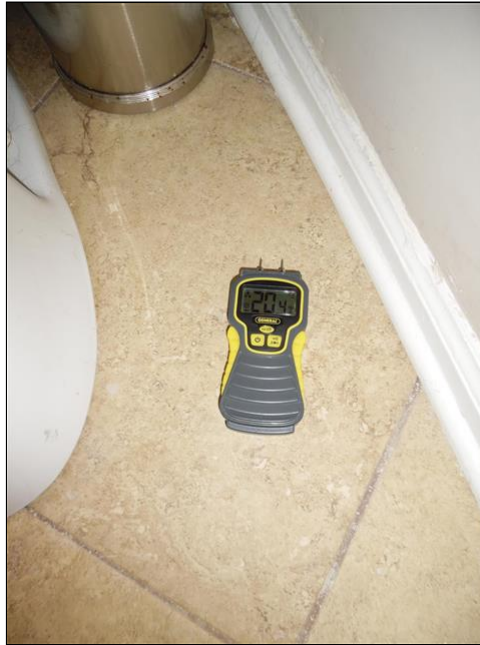
6.0 (1) While the toilet is secure to the floor, I did detect moisture with a moisture meter at the base of the toilet at the guest bathroom. This is most likely an indication of a faulty wax seal that needs to be replaced to avoid water damage to the subfloor. This is a minor repair.

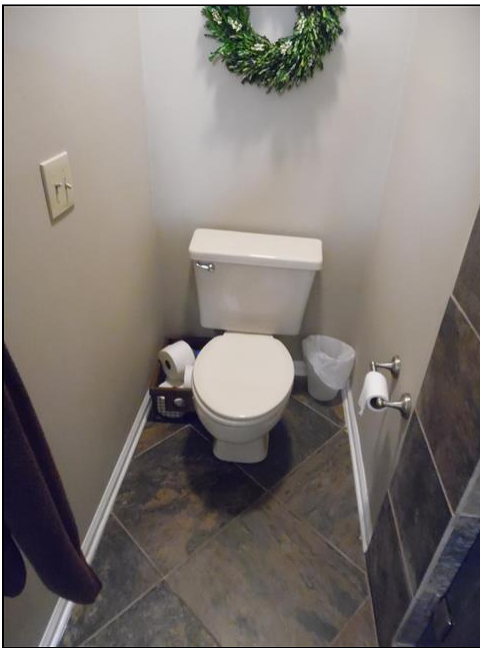
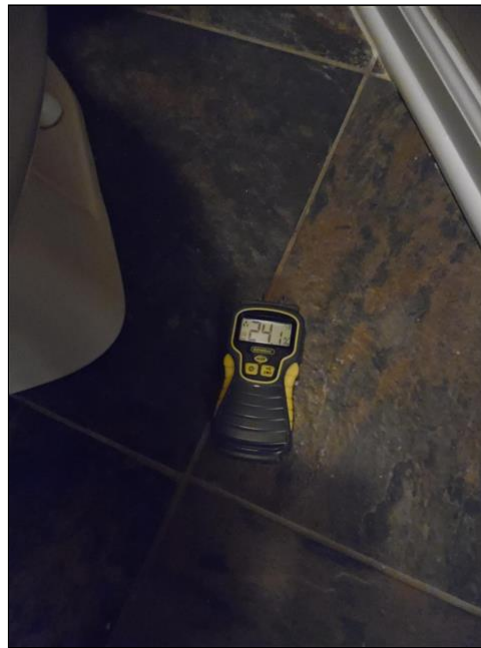
6.0 (2) The toilet is loose at floor at the master bathroom and I detected moisture at the base using a moisture meter. Minor repair to replace wax seal and secure toilet to the floor.

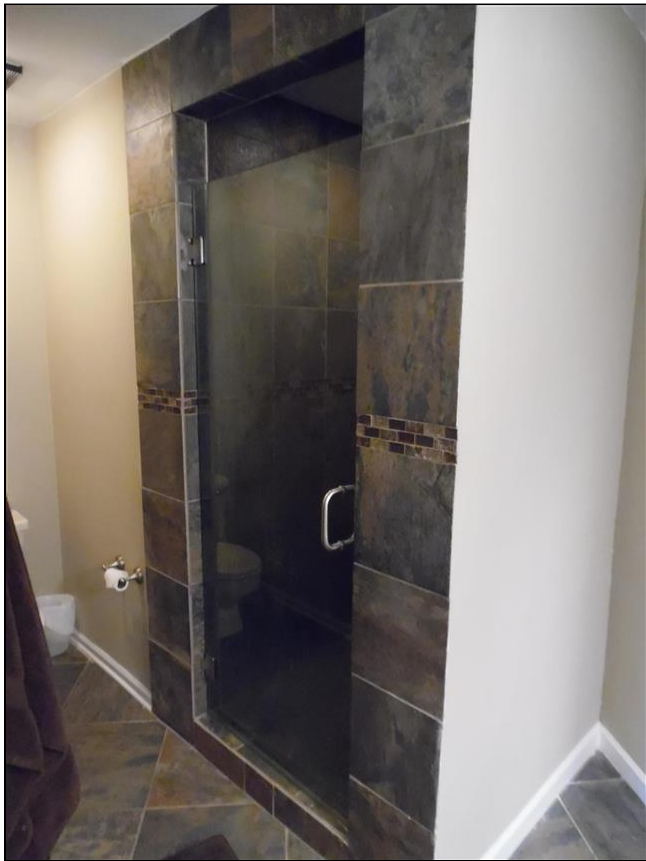
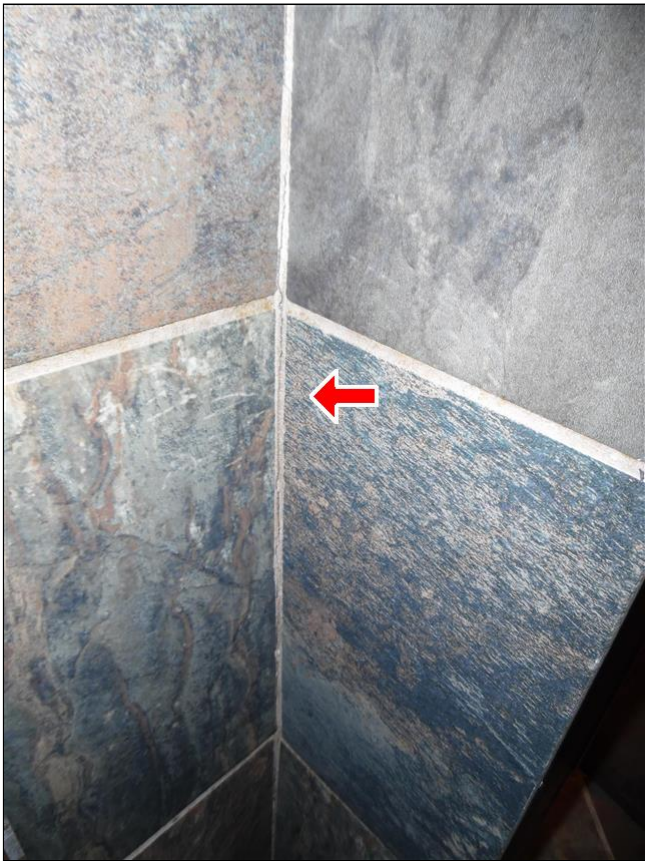
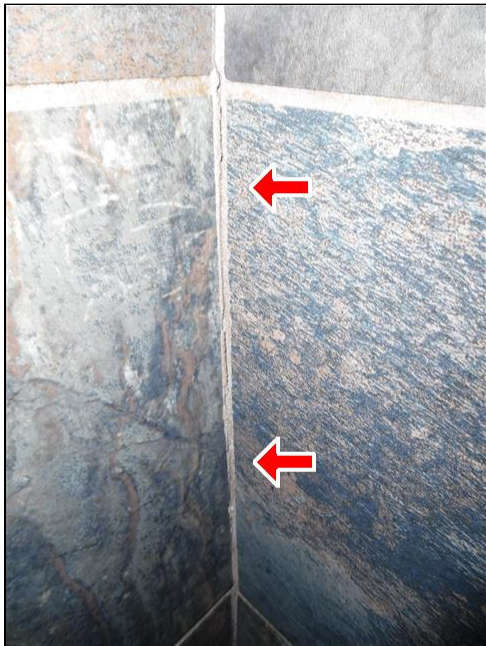
6.0 (3) Noted cracked grout inside master shower stall. This is at the inside right corner. While it is a small crack, the grout needs to be repaired to prevent long term water penetration behind the shower surround and subfloor underneath. Minor repair.

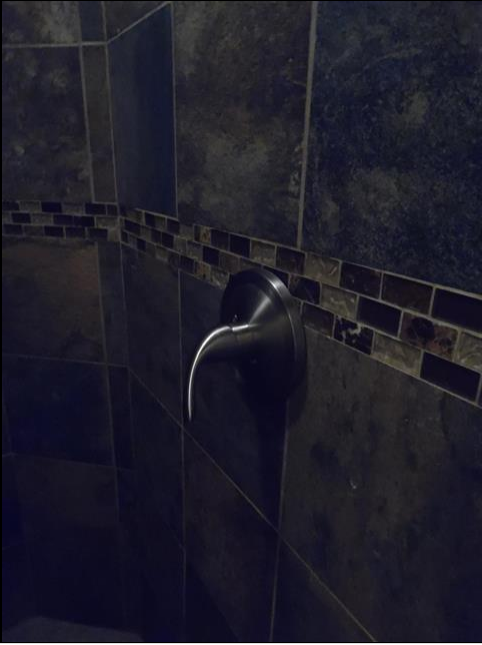
6.1 Item 1(Picture)

6.1 Overall, all the water supply fixtures were in satisfactory condition with the exception of the master shower water handle that is loose at the surround. Minor repair to tighten fixture.

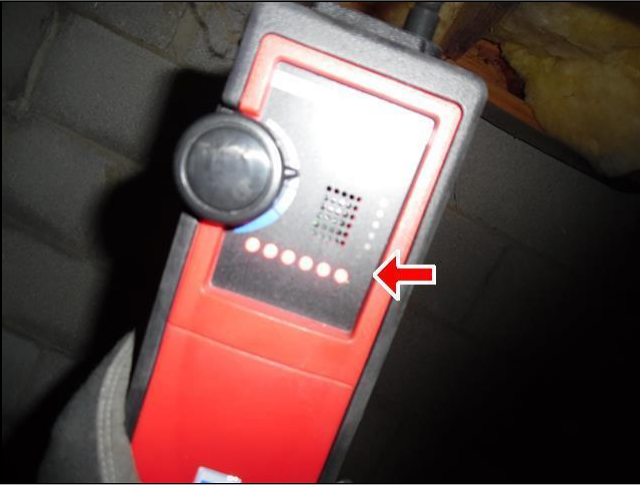
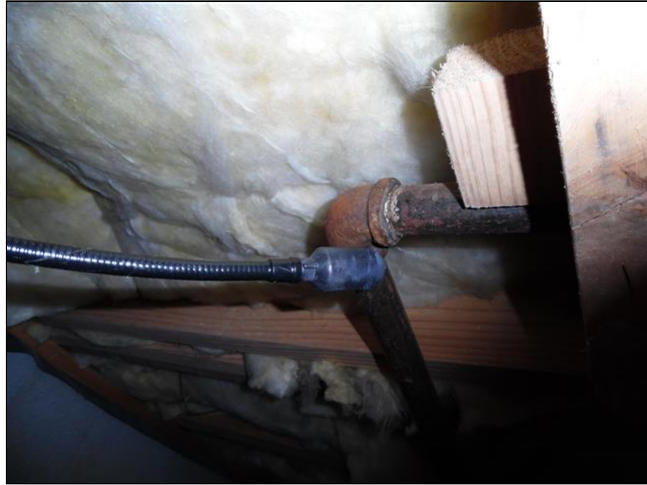
6.2 (2) Noted this elbow in the black iron gas pipe located in the crawlspace, coming from the gas meter, is leaking gas. This gas pipe feeds the water heater and the gas fireplace and the elbow is located toward the front of the home in the corner. The leak was confirmed by a combustible gas meter. There is enough gas emanating from this leak that you can smell it coming through the crawlspace vent located to the left of the stoop steps. This needs to be repaired immediately by a qualified plumber or gas company technician.

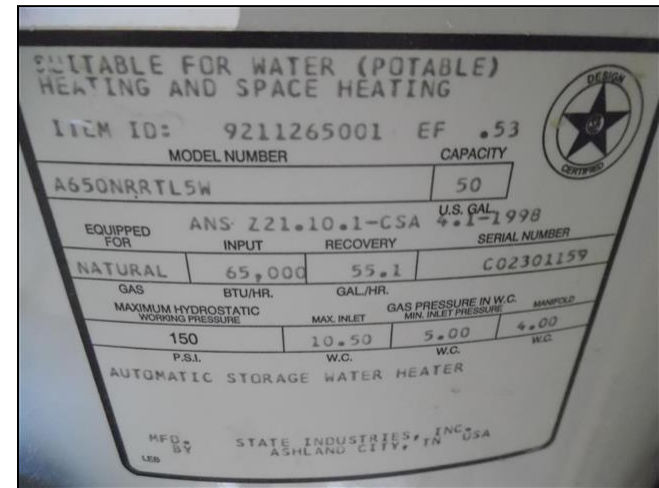
6.6 Item 1(Picture)

6.6 Water heater manufactured March 2002. Life expectancy of most water heaters range 5-10 years. Budget for replacement <5 years.

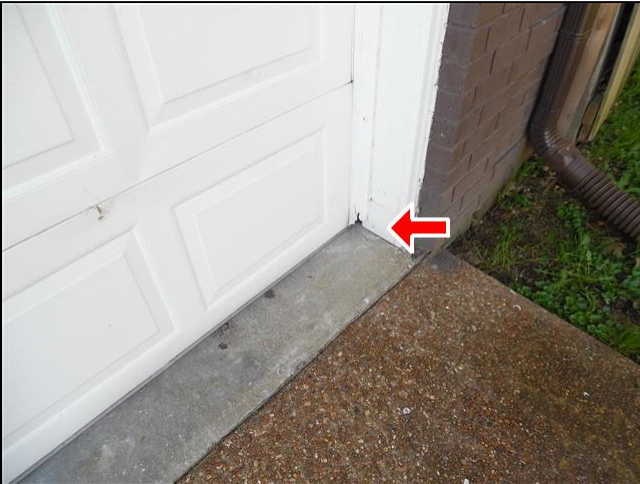
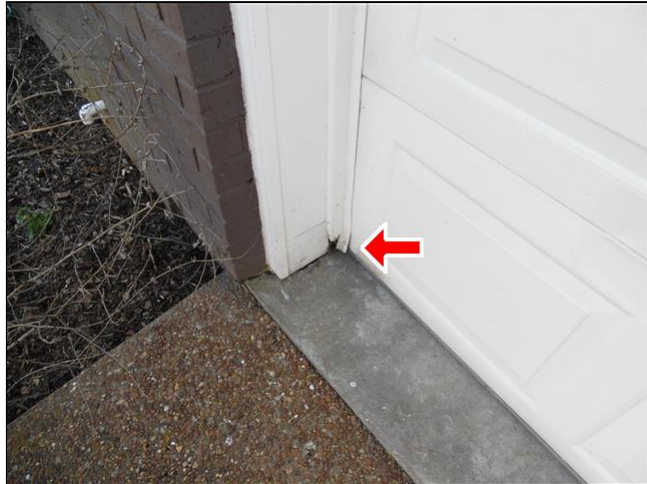
7.3 (1) Noted some minor wood deterioration at the base of the garage door frame. Minor repair with some wood putty and paint to prevent further deterioration.

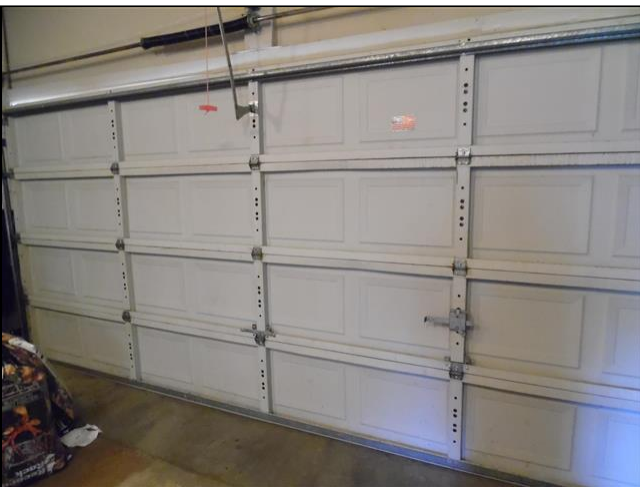
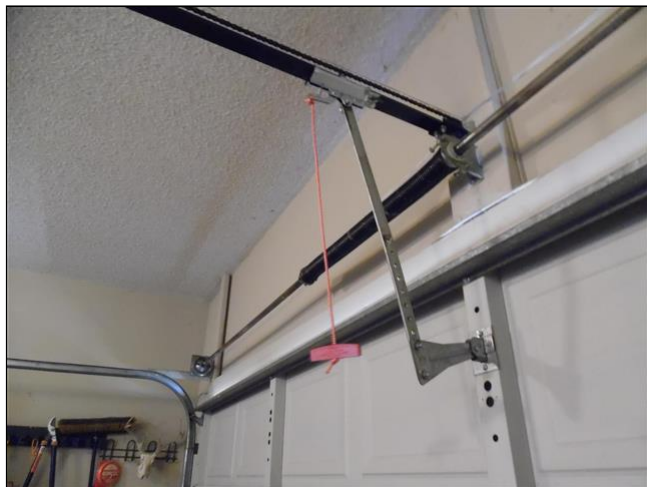
7.3 (2) The garage door does not easily lift and remain at the appropriate 3-4 ft from ground when the safety release is pulled. This is an indication of a broken or mal-adjusted tensioner spring. This will cause undue wear on your garage door opener system over the long term if not repaired. Minor repair.

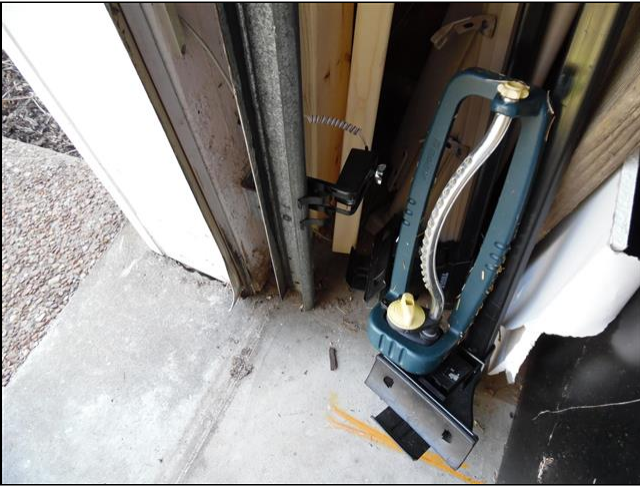
7.5 Item 1(Picture)

7.5 The sensors are in place for garage door(s) and will reverse the door. However, the door does not respond to resistance and safely auto reverse. Recommend evaluation by a qualified garage door technician to make adjustments or repair. Minor repair.
