Inspection Report

Sample Report #4

Property Address:
601 Bluewater Dr.
Nashville TN 37217

21st Century Home Inspections, LLC

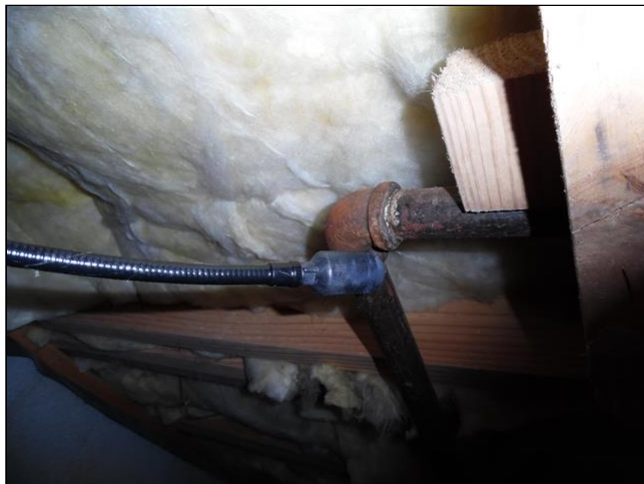
6.2 Item 5(Picture)

(2) Noted this elbow in the black iron gas pipe located in the crawlspace, coming from the gas meter, is leaking gas. This gas pipe feeds the water heater and the gas fireplace and the elbow is located toward the front of the home in the corner. The leak was confirmed by a combustible gas meter. There is enough gas emanating from this leak that you can smell it coming through the crawlspace vent located to the left of the stoop steps. This needs to be repaired immediately by a qualified plumber or gas company technician.

6.2 (2) Noted this elbow in the black iron gas pipe located in the crawlspace, coming from the gas meter, is leaking gas. This gas pipe feeds the water heater and the gas fireplace and the elbow is located toward the front of the home in the corner. The leak was confirmed by a combustible gas meter. There is enough gas emanating from this leak that you can smell it coming through the crawlspace vent located to the left of the stoop steps. This needs to be repaired immediately by a qualified plumber or gas company technician.

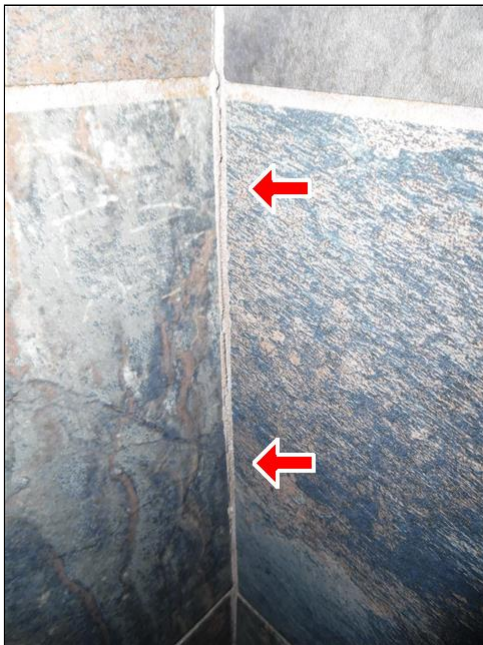
6.0 Item 6(Picture)

(3) Noted cracked grout inside master shower stall. This is at the inside right corner. While it is a small crack, the grout needs to be repaired to prevent long term water penetration behind the shower surround and subfloor underneath. Minor repair.

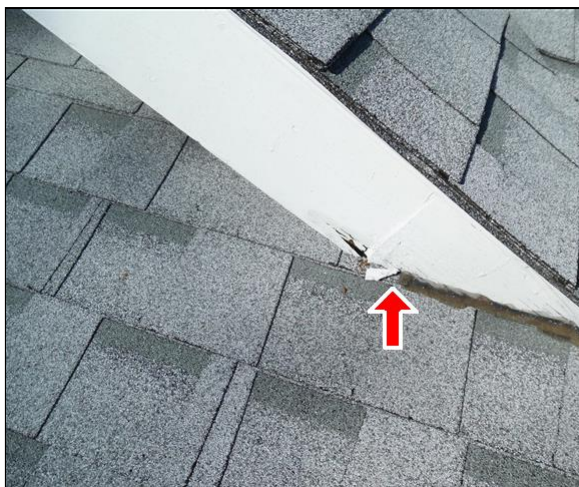
2.5 Item 1(Picture)

2.5 (1) Noted this small area of the rake board trim at the front of the home that had some wood deterioration at the interface between the trim and the roofing. Minor repair.

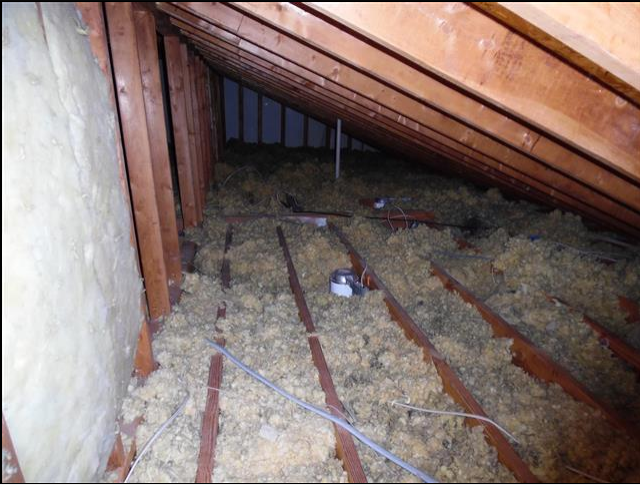
3.1 Item 1(Picture)

3.1 (1) Attic was sound structurally and I detected no major defects at the time of the inspection.

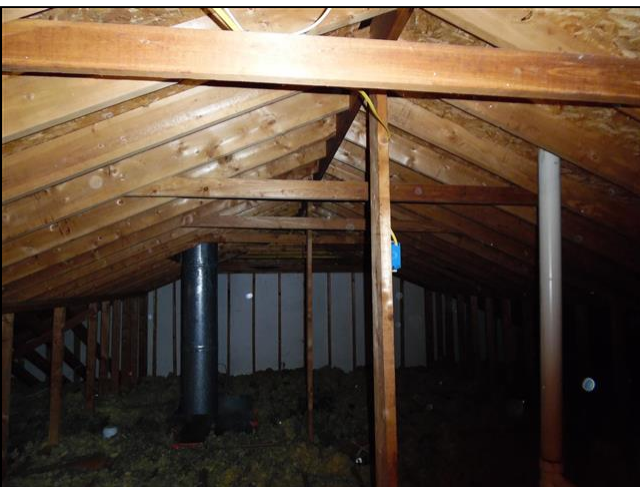
3.1 Item 3(Picture)

3.1 (2) I did note signs of water stains below this gable vent in the front of the home. It was dry at the time of the inspection and appears to be rain water that's blown from the vent. I'm unable to determine the frequency or extent of the leaking or if this is an active area. Monitor and address as needed.

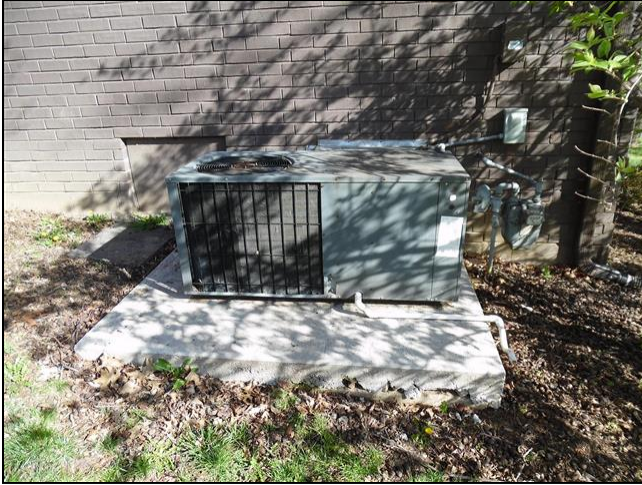
4.0 Item 1(Picture)

4.0 Manufacturers recommend a temperature differential of 40-60 degrees F between supply air and return air for normally operating heating systems. Using an infrared thermometer, the return air for your main Goodman package system was measured at 66 degrees and the supply air temperature was measured at 110 degrees and rising. This is an acceptable range.

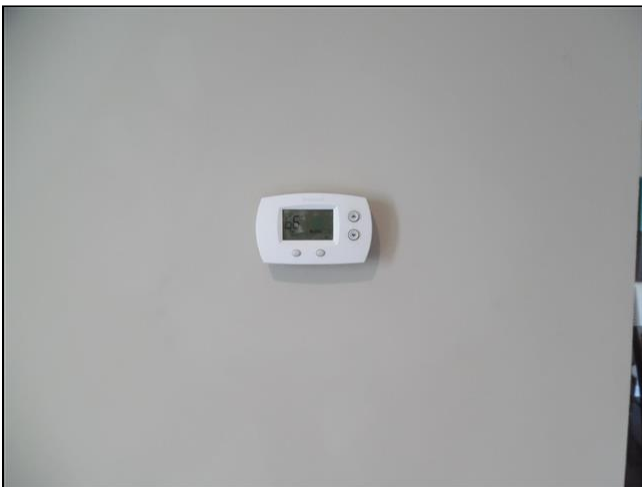
4.1 Item 1(Picture)

4.1 The thermostat responded to normal operation.

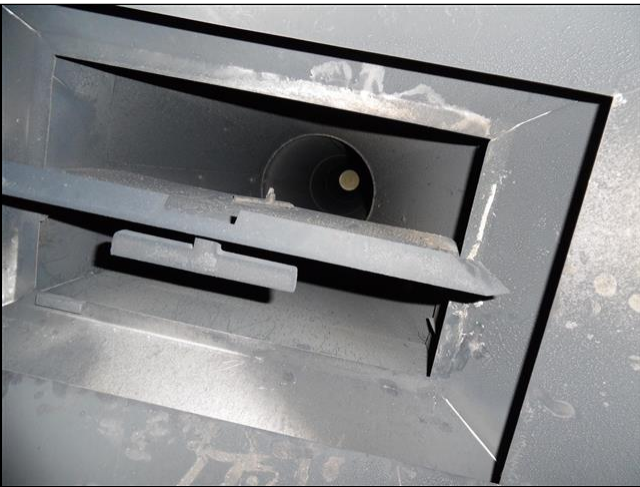
4.5 Item 1(Picture)

4.5 Could detect no obstructions inside fireplace flue entrance. Damper functioned properly.

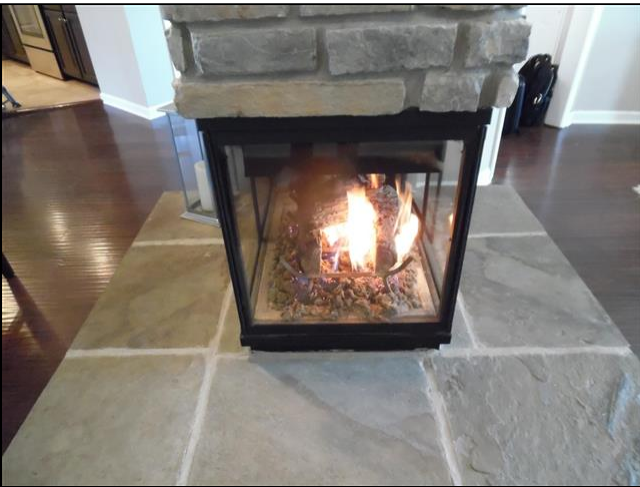
4.7 Item 1(Picture)

4.7 I was able to light the gas firelogs.

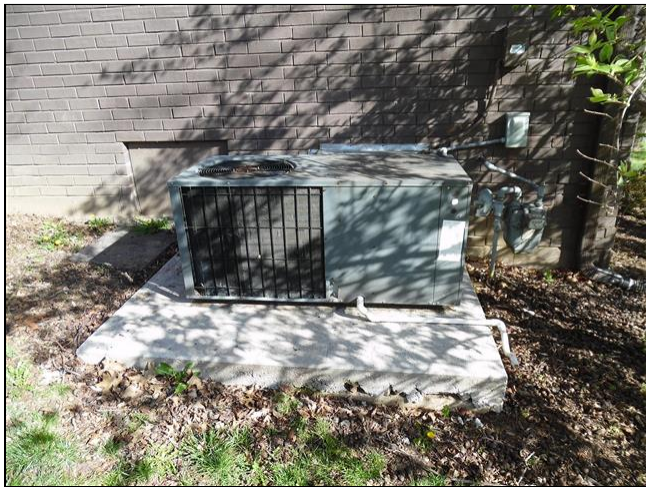
4.8 Item 1(Picture)

4.8 The ambient air test was performed by using thermometers on the air handler of the Goodman system in cool mode to determine if the difference in temperatures of the supply and return air are between 14 degrees and 22 degrees which indicates that the unit is cooling as intended. The supply air temperature on your system read 48 degrees, and the return air temperature was 68 degrees. This indicates the range in temperature drop is normal.

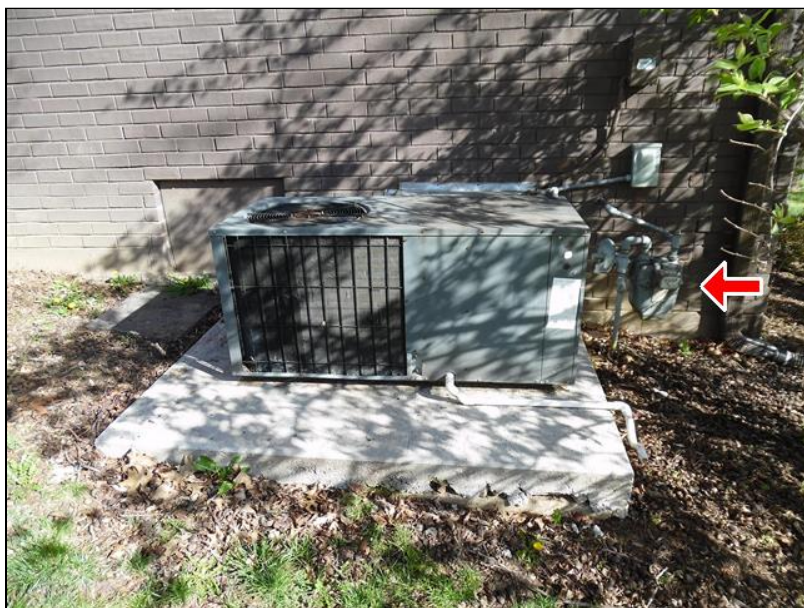
4.12 Item 1(Picture)

4.12 The main fuel shut off is at gas meter outside next to the HVAC unit. Left side of home.

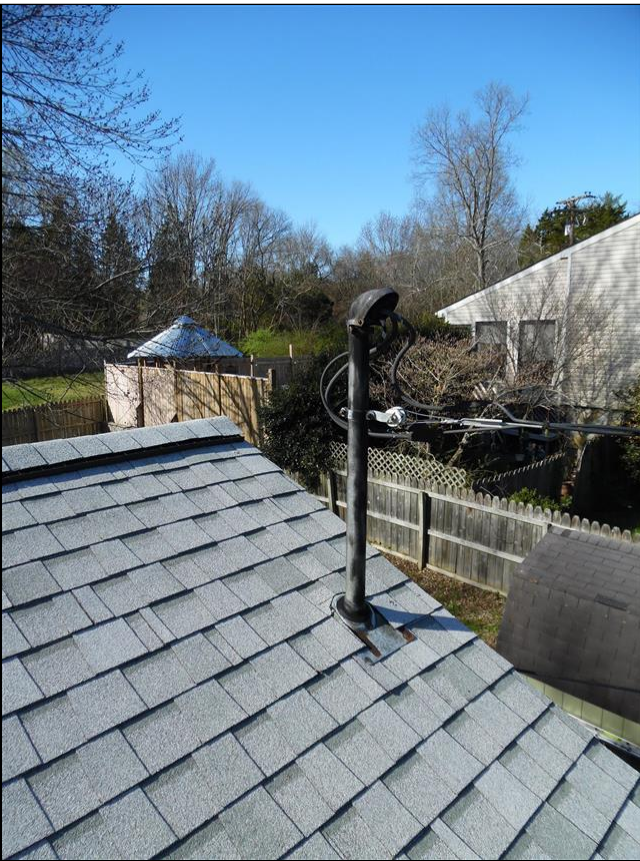
5.0 Item 1(Picture)

5.0 Service entrance mast secure and well supported.

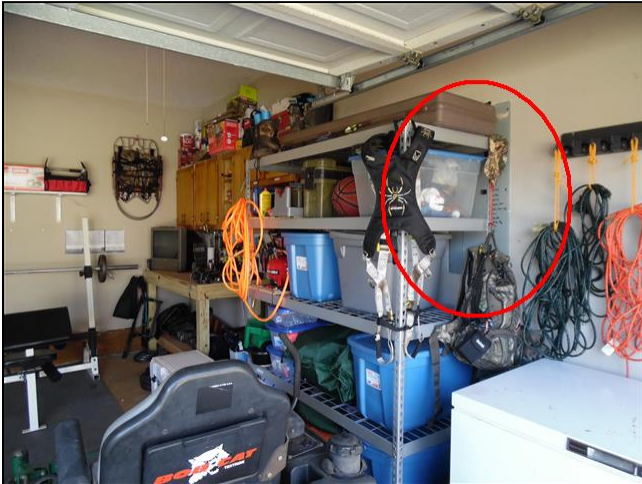
5.1 Item 1(Picture)

5.1 Was unable to inspect the inside of the electrical panel because the owners belongings were blocking access. There should be minimum 3 ft clearance kept in front of the electrical panel at all times.

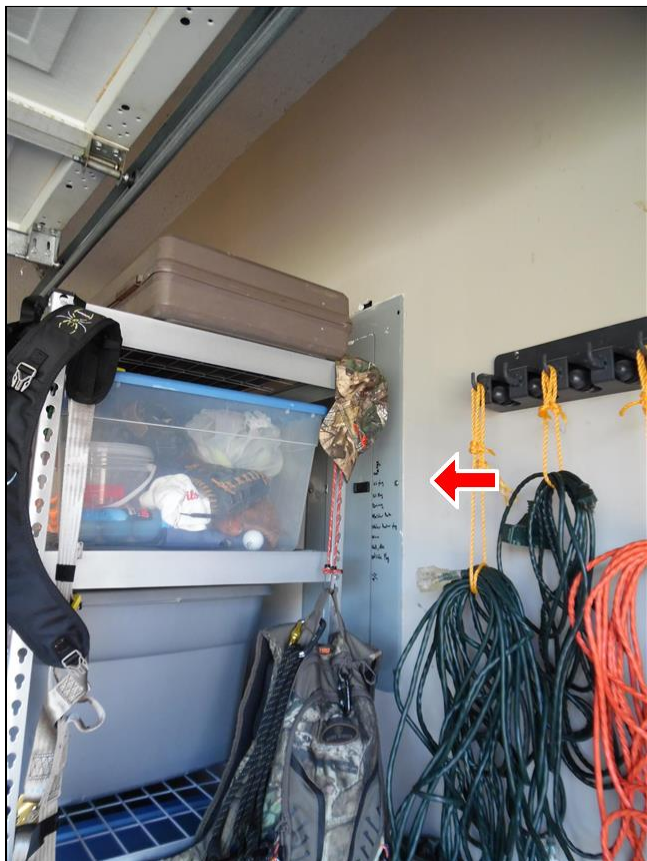
5.6 Item 1(Picture)

5.6 The main panel box is located at the garage.

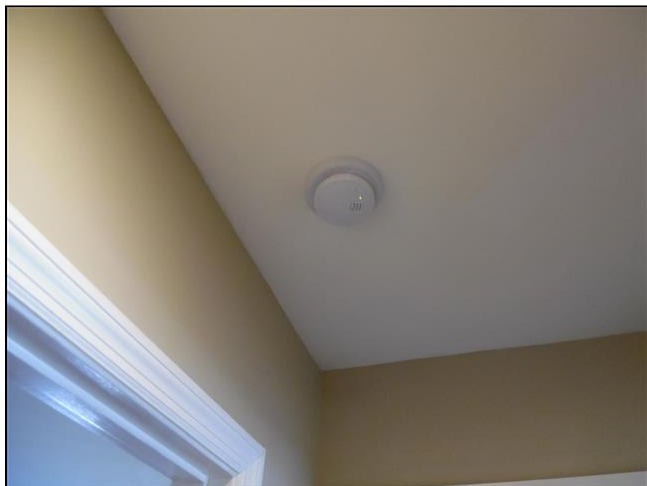
5.7 Item 1(Picture)

5.7 Smoke detectors in the house were tested and passed.

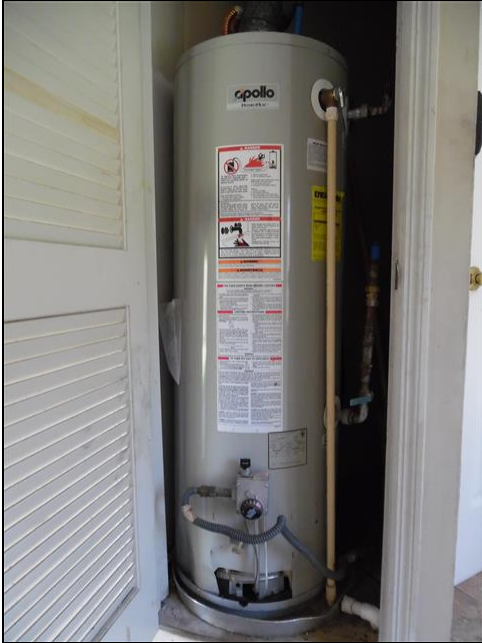
6.2 Item 1(Picture)

6.2 (1) The hot water system appears to be functioning properly. Noted a water pressure reducing valve located in the crawlspace. I recommend a thermal expansion tank be installed at the water heater when there is this type of valve in use in the home. This reduces water pressure stresses on both the home water piping supply and the TPR valve on the water heater. This is for informational purposes.

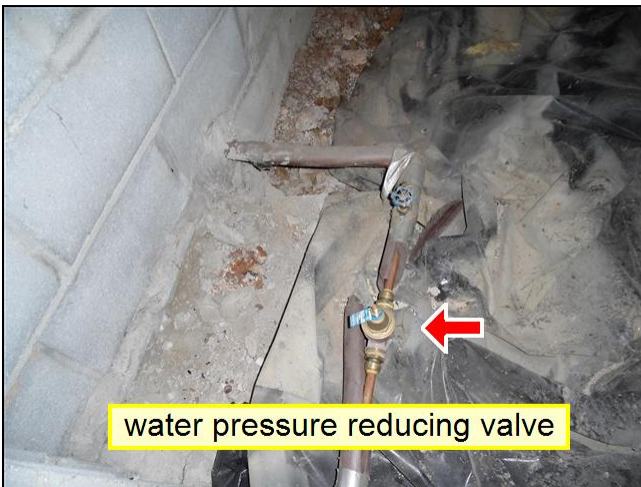
6.2 Item 3(Picture)

water pressure reducing valve

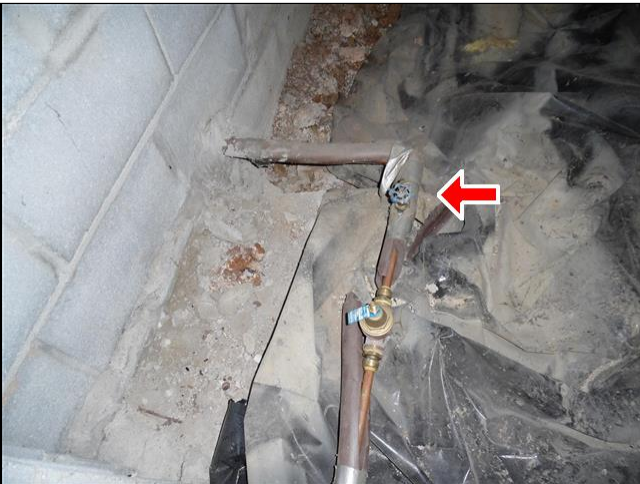
6.3 Item 1(Picture)

6.3 The main shut off is the knob located underneath in the crawlspace. This is for your information.

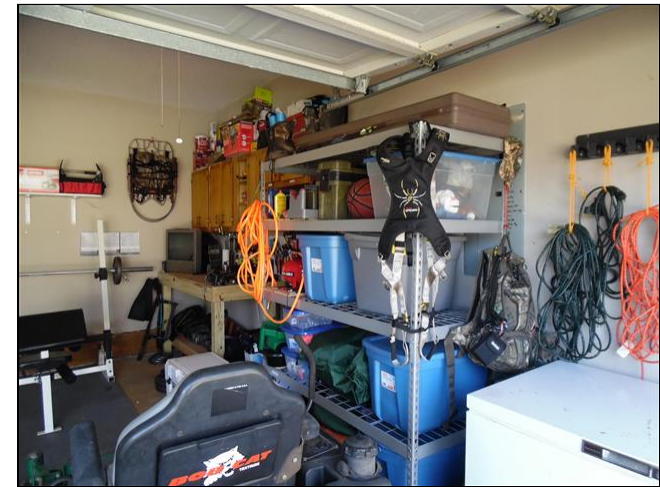
7.1 Item 1(Picture)

7.1 I was unable to inspect one of the garage walls because of the current owners belongings.

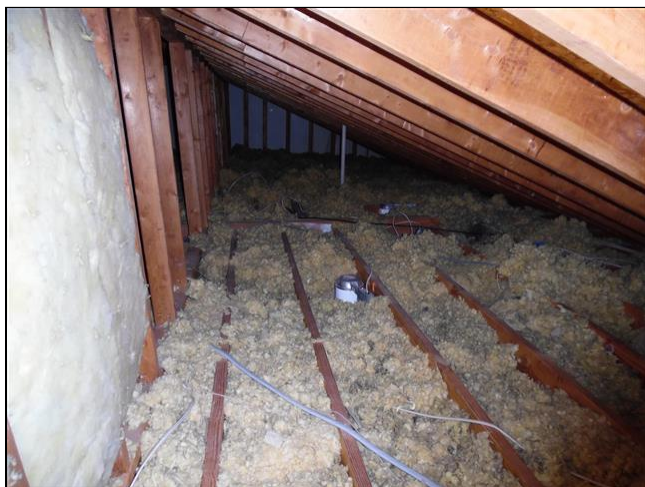
8.0 Item 1(Picture)

8.0 Insulation is inspected for presence or damage, but Standards of Practice for Tennessee do not require inspection for adequacy relating to R value. In general, you should not be able to see the ceiling joists, so this attic should be supplemented with insulation as needed to increase the R value.

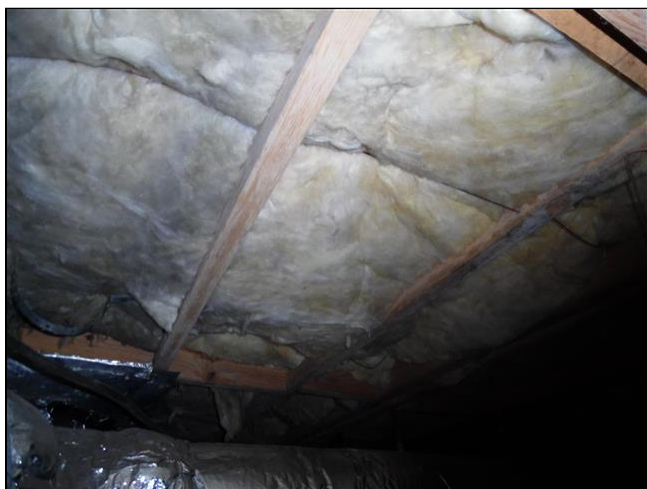
8.1 Item 1(Picture)

8.1 The floor structure insulation appeared to be in satisfactory condition, free of damage.

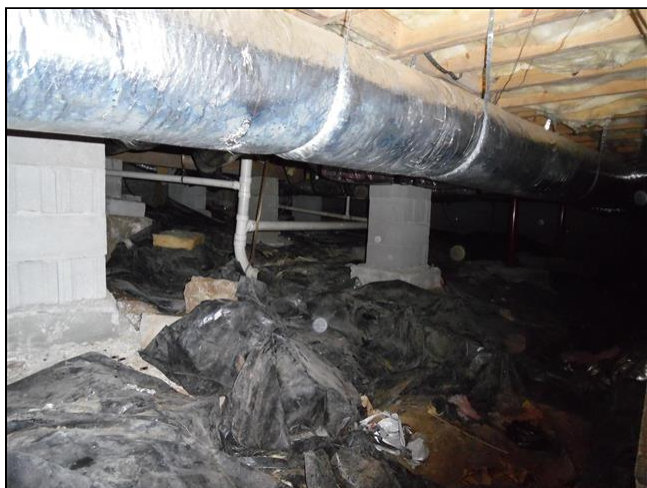
8.2 Item 1(Picture)

8.2 Vapor barrier was present and covered the grade effectively.

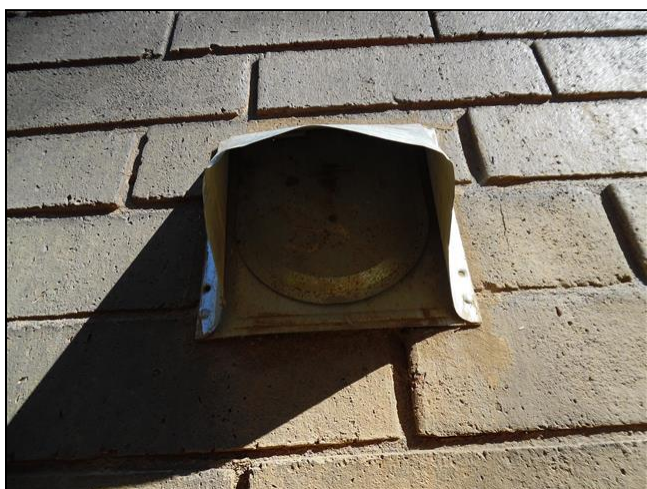
8.4 Item 1(Picture)

8.4 While I detected no defects in the dryer vent and the length is within acceptable standards, it's recommended dryer vents be cleaned on an annual basis to clear built up lint to avoid a fire hazard.

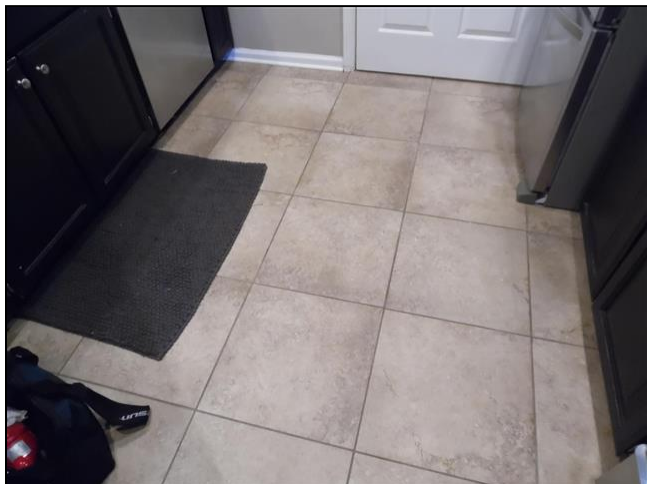
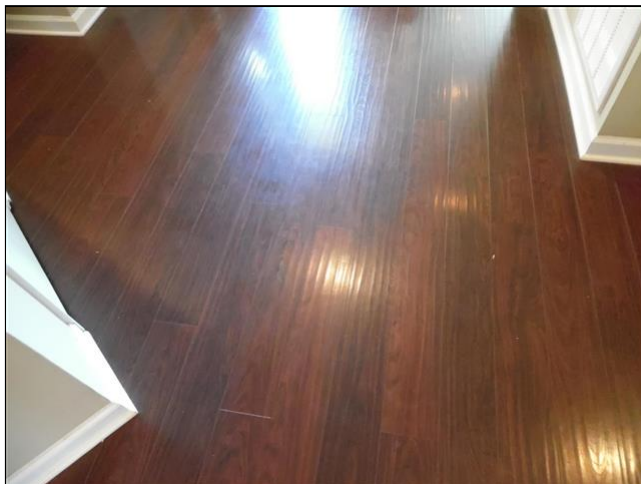
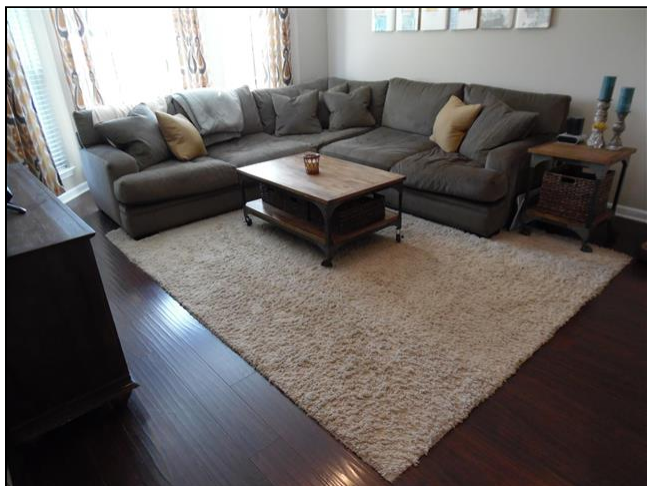
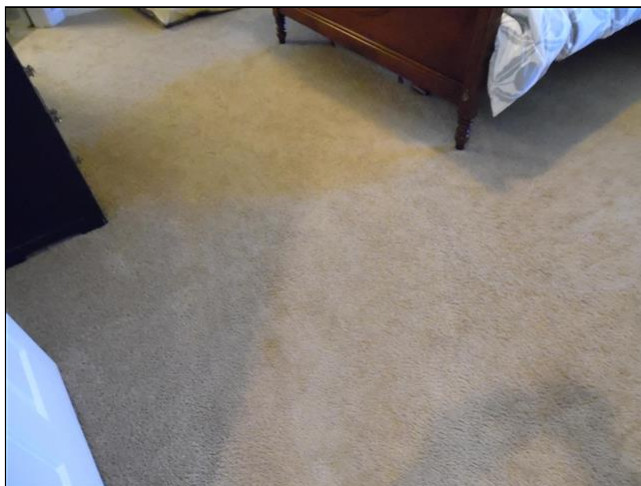
9.2 Floor coverings were inspected where visible. Unable to inspect floors where carpeted or covered by area rugs or furniture.

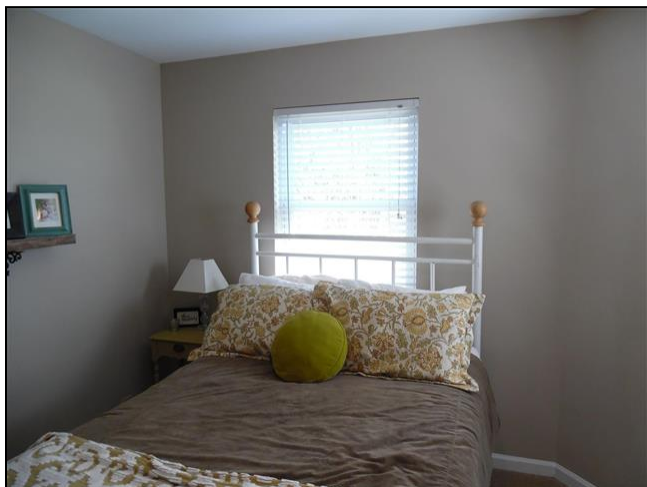
9.4 Item 1(Picture)

9.4 All interior windows were tested for operation with the exception of this one window in the extra bedroom. Unable to access because of owners belongings.
